A Health Assessment of Lubricating Oil in Two Australian Army CH-47D Helicopters

DSTO-TR-1594

Air Vehicles DivisionPlatforms Sciences Laboratory

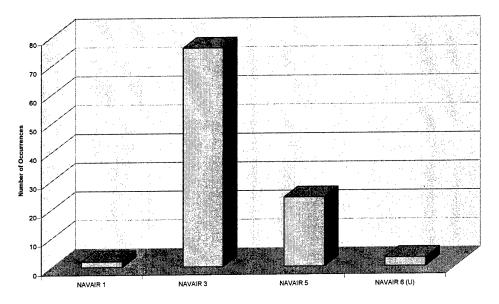
Figure 2: Histogram of NAVAIR Colour Rating

The NAVAIR colour rating for each sample revealed only three instances of unacceptable contamination out of the 105 samples analysed. This aspect of the patch assessment refers only to the overall colour of the patch (which relates to the presence of particles up to approximately 40 micron) and does not provide any indication about the presence of visible particulate (which relates to particles approximately 40 micron and larger). Figure 2 is a histogram of the results obtained for the entire set of samples and shows that the majority of samples returned a NAVAIR rating of 3, which can be considered a good result for a lubrication system. All of the NAVAIR 6 (Unacceptable) samples came from different types of components fitted to aircraft A15-202 (No. 2 Engine, No. 1 Engine Transmission and the Forward Transmission). This may indicate wear-in of components given the relatively low operational hours of the major assemblies of this aircraft.

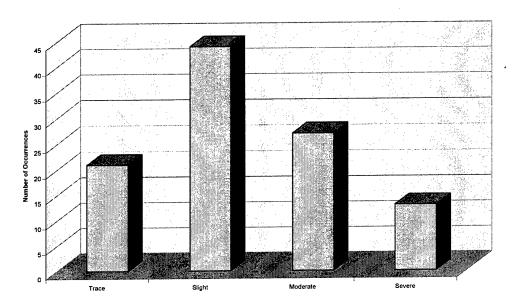
Figure 3: Histogram of Visible Particulate Contamination

The visible contamination assessment was conducted using the newly created scale (see Appendix A.1). Thirteen instances of severe visible contamination were identified, one of which was contaminated to the extent that an immediate oil flush was ordered for that system [10]. Figure 3 shows a histogram of the visible particulate results and shows that the majority of samples contained Slight or Trace levels of visible contamination. Figure 4

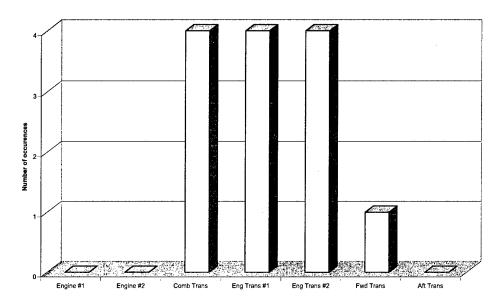
Figure 4: Distribution of Severe Visual Contamination

shows the distribution of the samples graded as Severe and shows that the majority of instances were recorded from samples taken from the Combining Transmission and Engine Transmissions (as previously stated there is a common segmented housing for the reservoirs of these transmissions).

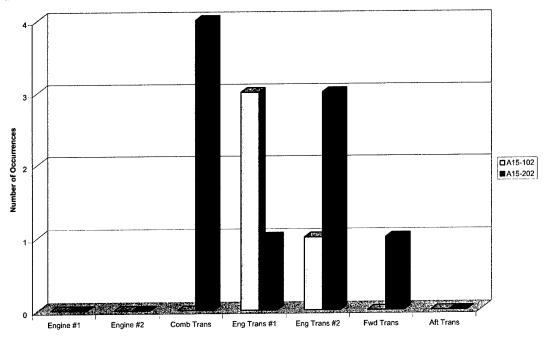
Figure 5: Comparison of Gross Visible Contamination by Aircraft Tail Number

Figure 5 shows the distribution of the Severe visual contamination by aircraft tail number. Interestingly, the newer aircraft (A15-202) shows more instances of severe visible contamination than the fleet leader (A15-102). As can be seen in Table 2, most major assemblies fitted to A15-102 had operating hours in the range 900 to 3000 hours

(with the exception of No. 1 Engine Transmission). The No. 1 Engine Transmission had been replaced and only had 121.9 operating hours at the commencement of the sampling period. Interestingly it was this transmission that returned three of the 4 Severe particulate

results. At the commencement of this trial all major assemblies fitted to A15-202 had 221.7 operating hours.

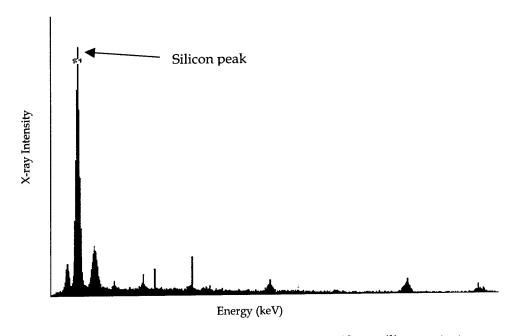
Figure 9: SEM EDS spectum of typical debris showing significant silicon content

Samples of the Severe visible contamination were analysed using a Scanning Electron Microscope (SEM) in order to ascertain the origin of the particulate. Analysis of the particulate revealed that the majority of the visible contamination was silicon-based grit up to 200 micron [11], however particles up to 600 micron were observed on some patches. Initially, it was thought that the contamination could have been manufacturing residue from grit blasting procedures, however corundum (Al_2O_3) is the standard grit used for aeronautical applications. Figure 7 shows an example of the severe visible contamination observed.

Figure 8 shows a typical SEM image of the severe visible contamination found during this investigation. Figure 9 shows the Energy Dispersive Spectroscopy (EDS) spectrum from a typical contaminant and shows the dominant silicon peak.

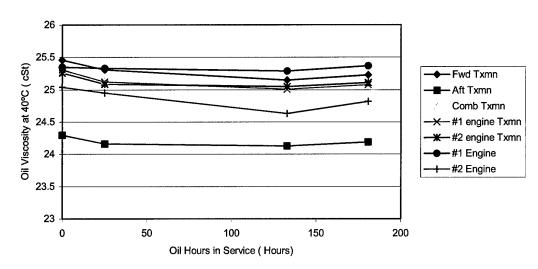
Figure B1.1 A15-102 Viscosity trend data

systems examined. The engine oils have not been subjected to significant thermal stress and the viscosity improver in the transmission oils has not degraded through shearing.

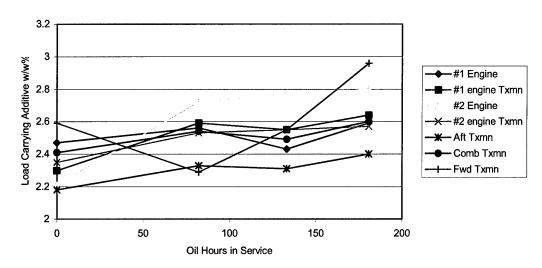
Figure B1.4 A15-102 Load Carrying Additive Trend Data

None of the systems examined showed a loss of TCP with time in service (Figures B1.4 and B2.4). Some systems showed an increasing trend in TCP concentration, which is due to top-up oil. The method used to determine the TCP concentration was found to have a relatively large standard deviation. An alternate method for determining the TCP concentration of the oil was trialed. This alternate method was based on measuring the phosphorus content of the oil and had a significantly better precision. It is recommended that if the load-carrying additive is to be monitoring routinely then the phosphorus concentration of the oil be monitored under the SOA program, as this will provide a significantly more accurate method for quantifying the TCP levels in the oil.

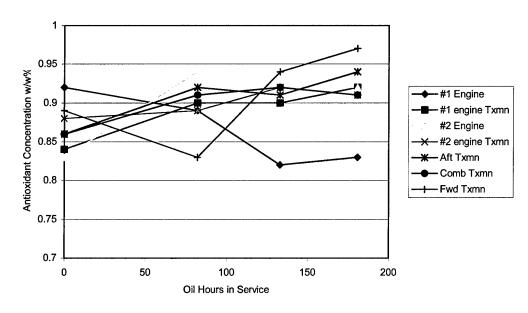
Figure B1.5 A15-102 Antioxidant Concentration Trend Data

The increases in antioxidant (AO) concentration of A15-102 forward transmission correspond with oil top-up (Figure B1.5). The No. 1 Engines for both A15-102 and A15-202 (Figure B2.5) showed a minor decrease in AO with time in service, which is expected for normal engine operations. The No. 2 Engines for both aircraft have essentially unchanged AO levels. The engines in both CH-47D helicopters examined were not degrading the oil due to thermal stress.

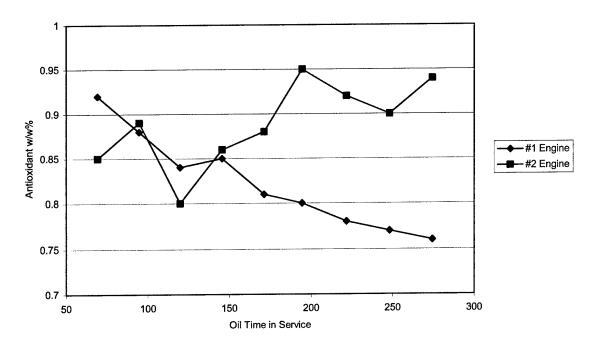
Figure B2.5 A15-202 Antioxidant Trend Data

The inter-dependence of oil chemical properties can be seen by examining the A15-202 No. 1 Engine AO concentration which depletes with time in service and this engine shows a corresponding increase in TAN, that is acidic by-products of the oxidative degradation of the oil have been formed. These changes in antioxidant and TAN for this engine are small and the oil is well within maximum limits.
